Photographic Log, CES Environmental Services Facility Site Visit, Houston, Texas

The following photographs were taken and described by Terry Andrews, Remediation Division, Texas Commission on Environmental Quality (TCEQ), while visiting the CES Environmental Services (CES) facility in Houston, Texas on August 2, 2014, from approximately 8:30 to 11:20 AM and August 12, 2014, from approximately 1:30 to 2:30 PM. The goal of both of these site visits was to investigate the source of the oily water release that had been reported on Kingsbury Ave on 8/1/2014.

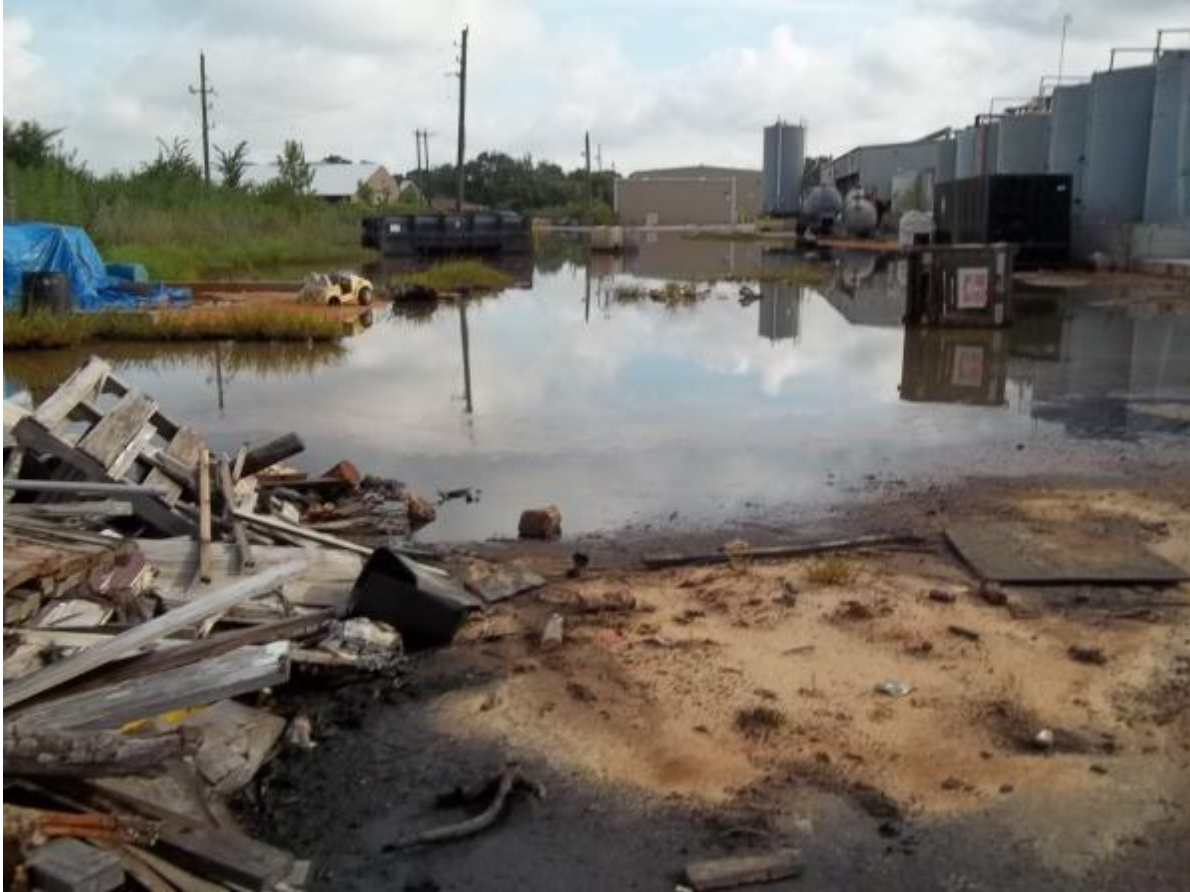
Photograph #1, August 2, 2014 – View looking north at the stormwater ponded in the southwest corner of the site. Light Non Aqueous Phase Liquid (LNAPL) that consists of a black oil-like material and a reddish emulsion-like material is floating on the surface of the stormwater. It looks like the light wind out of the north has pushed the LNAPL to the southern edge of the ponded stormwater. There are numerous potential sources of hydrocarbons in the area (such as oily stained concrete, oil stained debris, and oily waste containers).

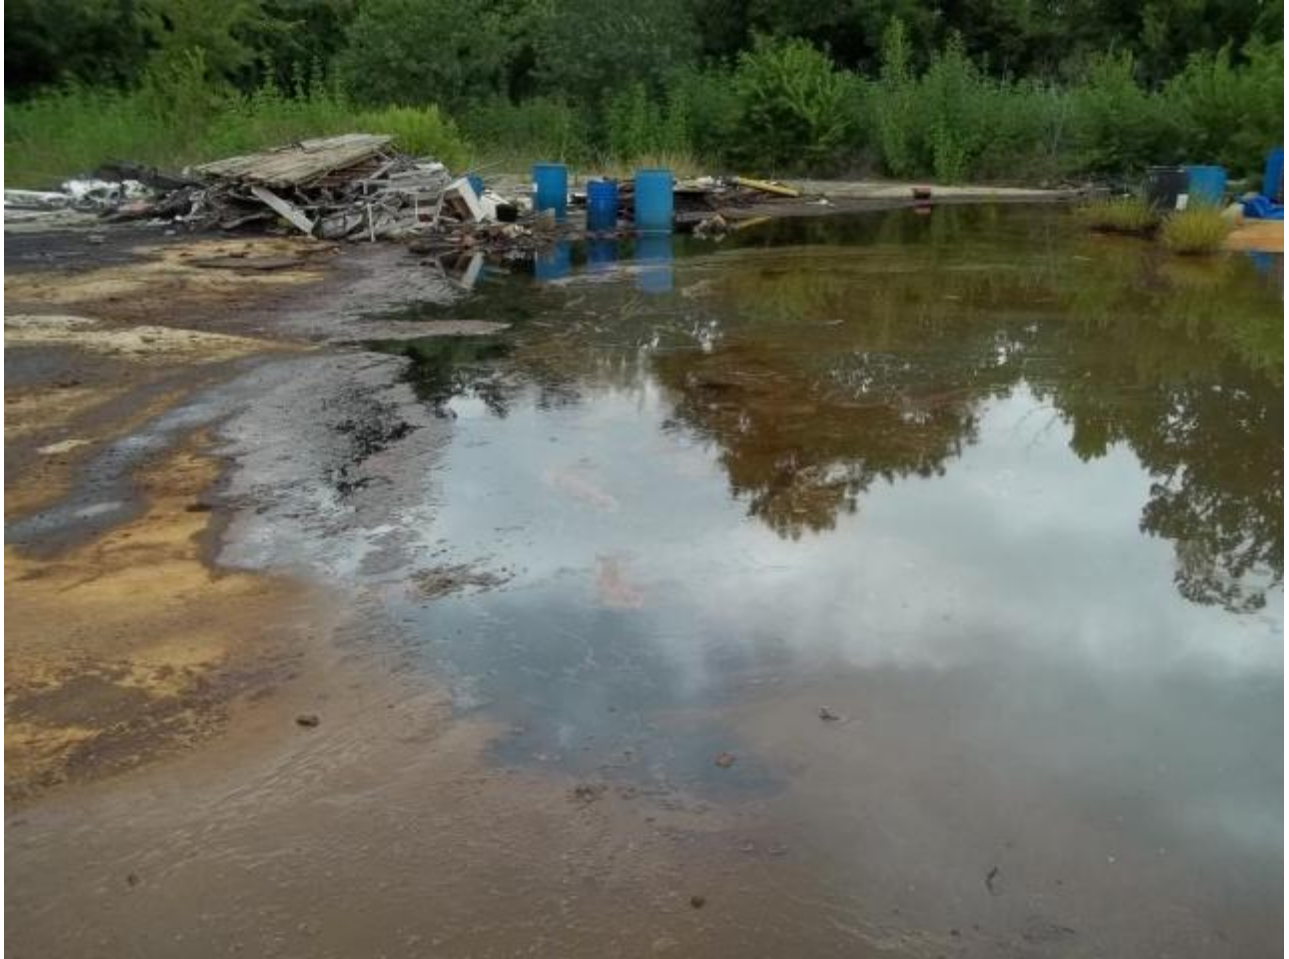
Photograph #2, August 2, 2014 - View looking west at the southern edge of the ponded stormwater in the southwest corner of the site. Note the LNAPL that is floating on the stormwater.

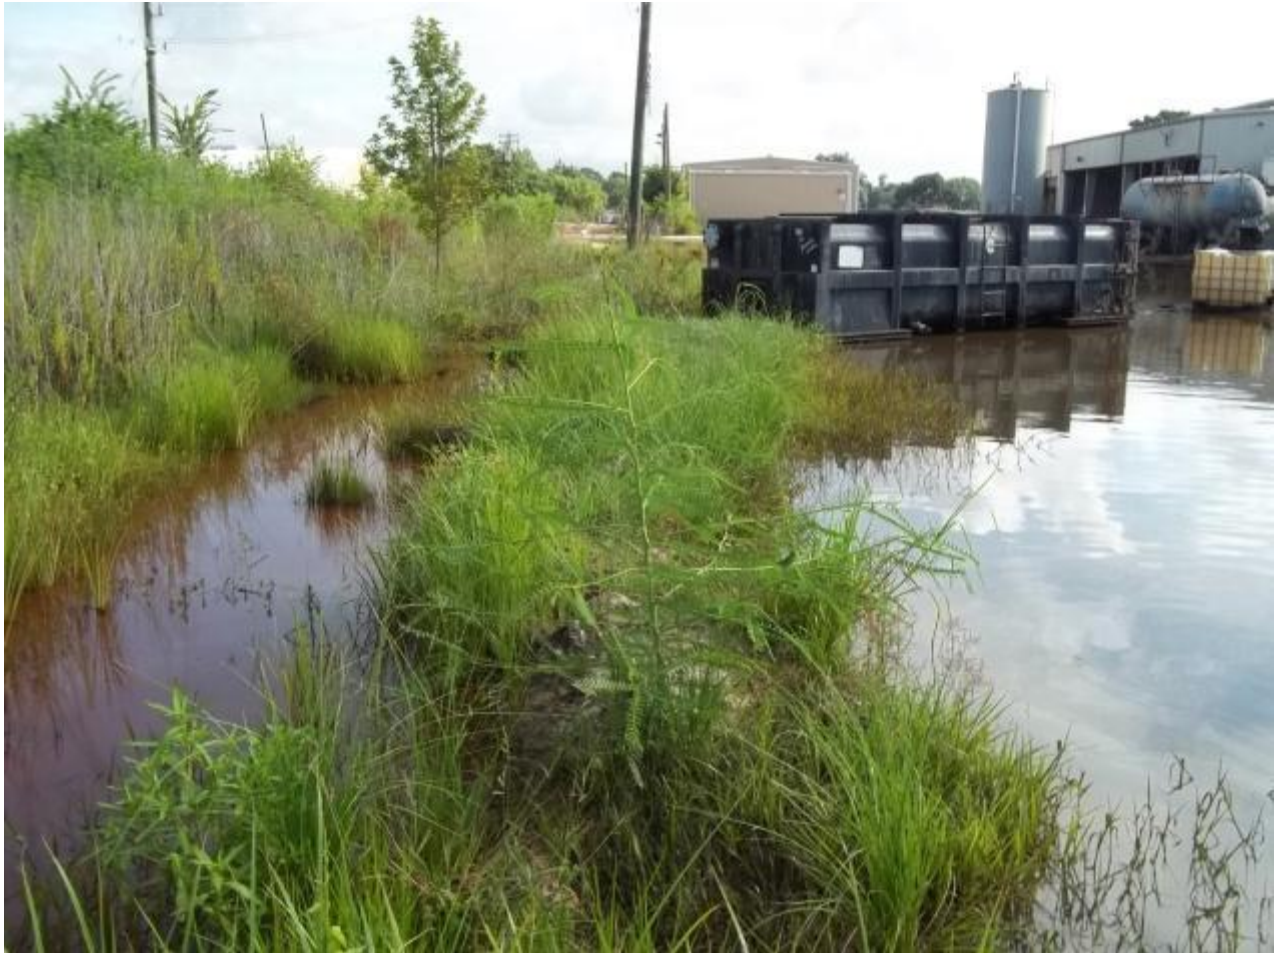
Photograph #3, August 2, 2014 - View looking north along the top of the clay berm that was built by the Bankruptcy Trustee in March 2014. The stormwater on the left side of the berm appears to have a layer of LNAPL/emulsion floating on it.

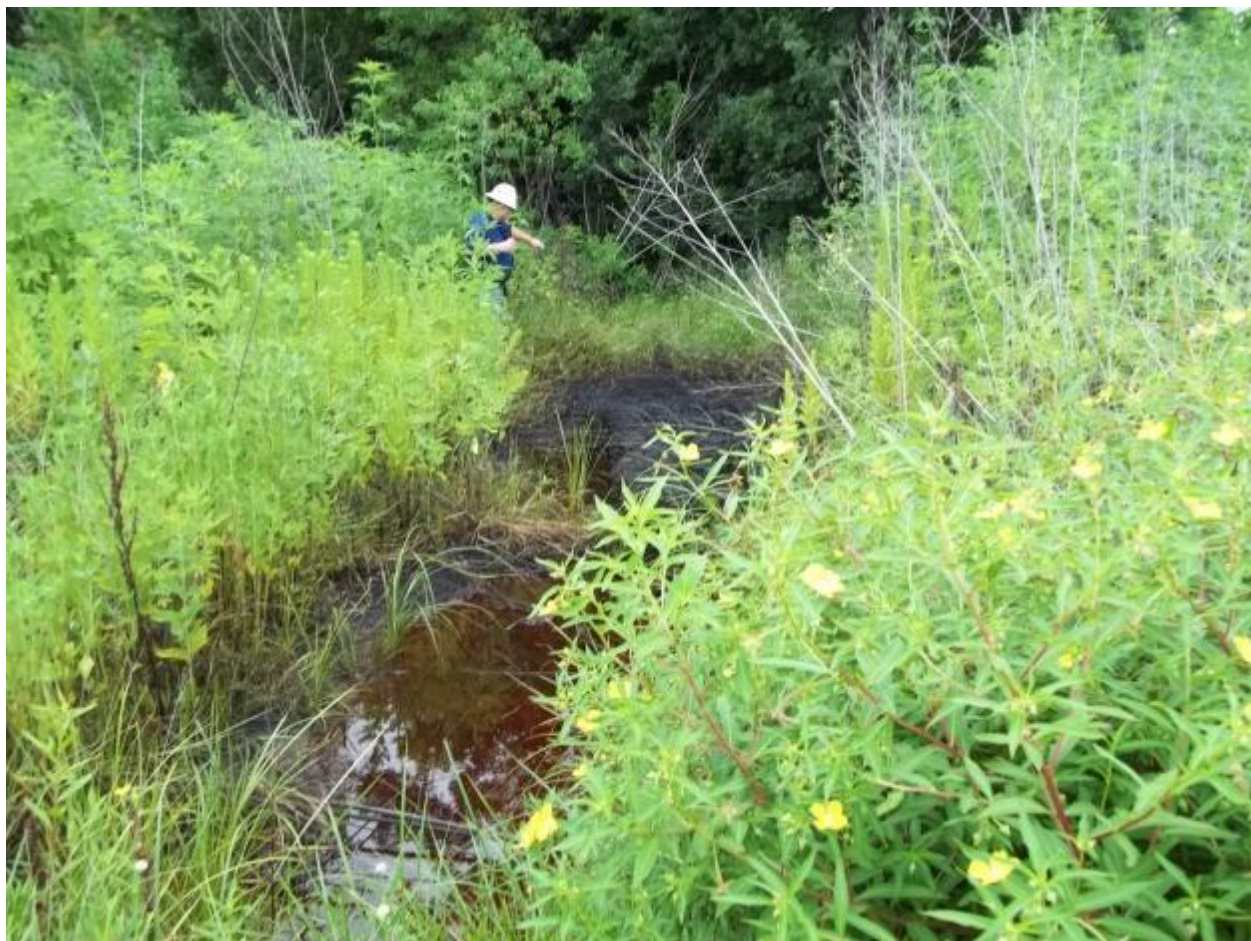
Photograph #4, August 2, 2014 – View looking southwest down the drainage ditch that is filled with stormwater with a layer of LNAPL/emulsion floating on it. The drainage ditch drains south towards Kingsbury Avenue and the earthen berm that was built by the City of Houston on 8/1/2014. Note the red color of the emulsion and the black color of the oil. Tom Waller, of Weston Solutions, Inc., is looking at the ditch.

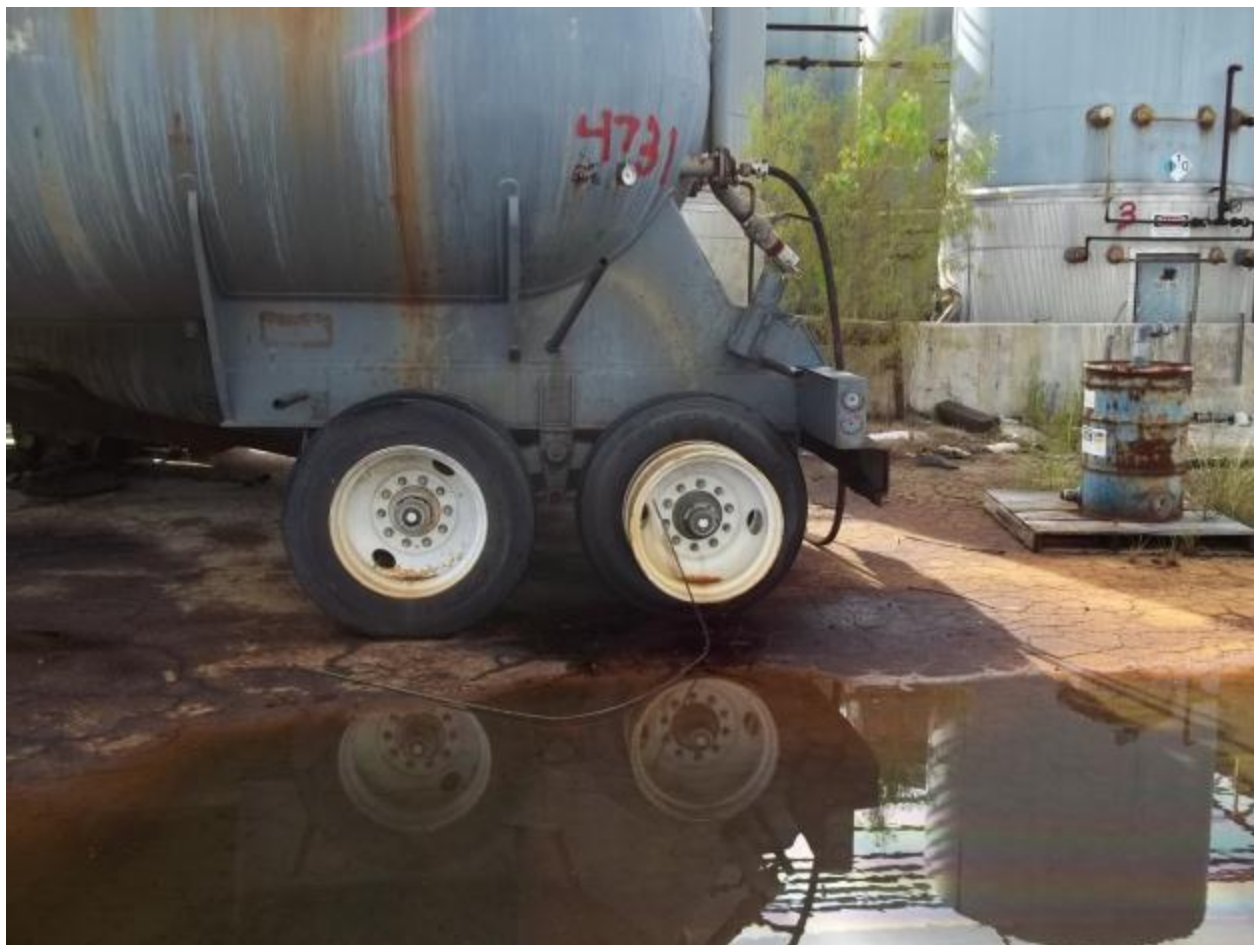
Photograph #5, August 2, 2014 – View looking east at a tank trailer that is parked along the North Tank Farm and near the ponded stormwater in the southwest corner of the site. The tank trailer contents are unknown. A small pipe and valve located just below the hand painted “4” was releasing a small trickle of black oil-like material onto the pavement and the ponded water. I closed this valve and stopped the trickle of oil-like material. The oil-like material resembles the LNAPL that we see floating on the ponded stormwater.

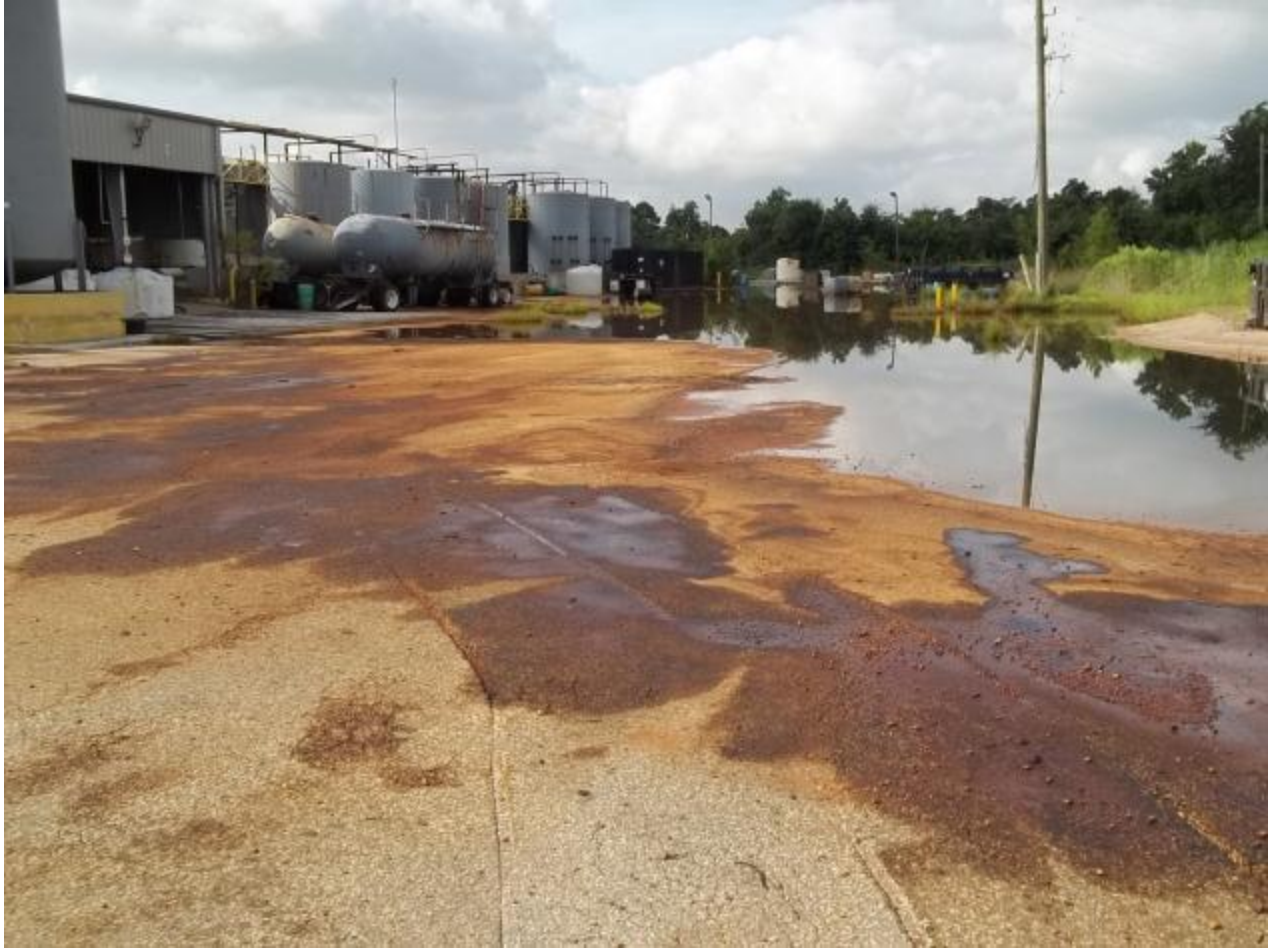
Photograph #6, August 2, 2014 – View looking south at the ponded water in the southwest corner of the site. The northern edge of the ponded water is located approximately 75 feet south of the gate located at the end of Wayland Street. To the left in the photograph is the Bay Wash Out building and the North and South Tank Farms.

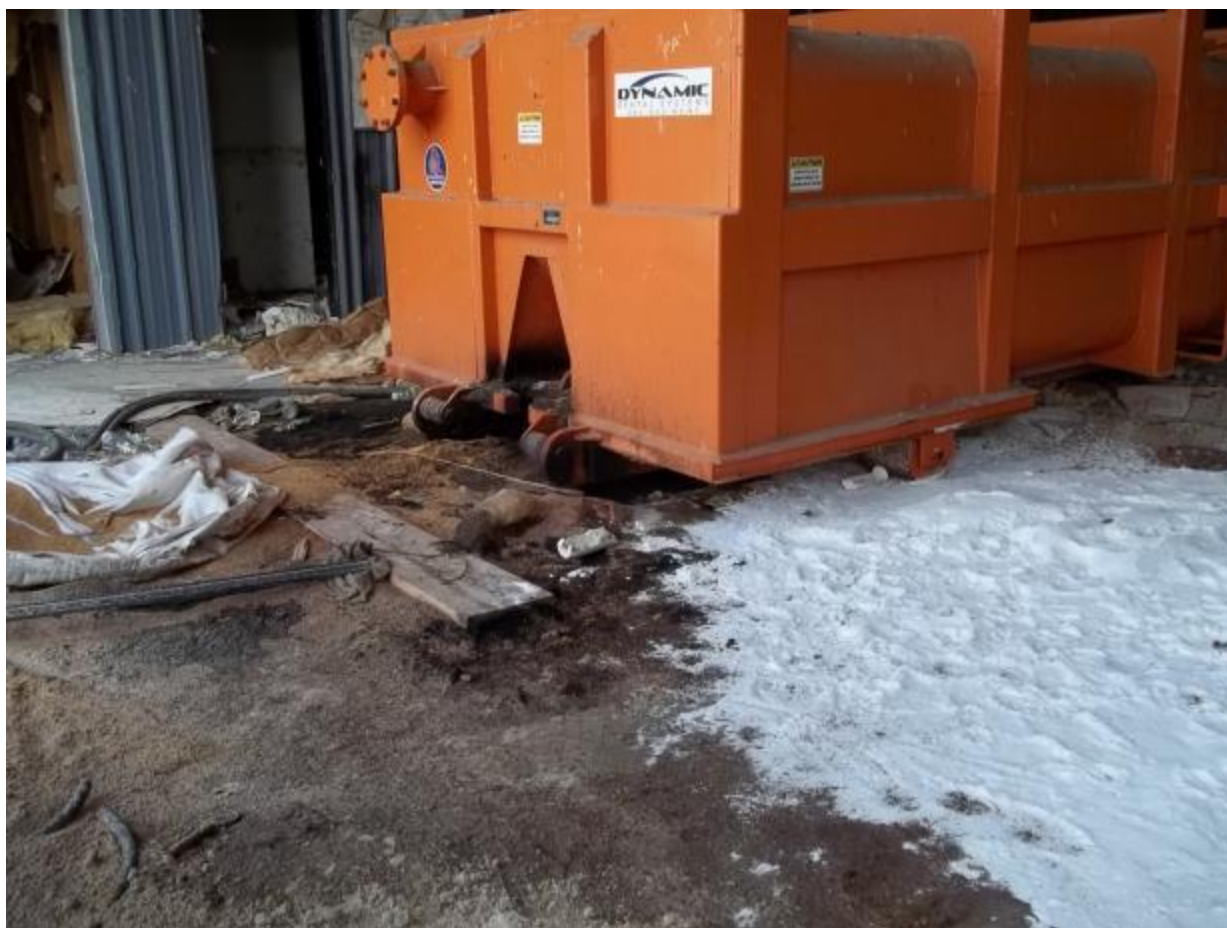
Photograph #7, August 2, 2014 - View looking northeast at one of the two vacuum boxes that are located within the Bay Wash Out building, which is located just north of the North Tank Farm. Both of these vacuum boxes appear to be leaking from the bottom of the containers and are emitting a strong phenolic odor. The floor is littered with absorbent material, some of which appears to be holding spilled or leaked waste. Soil berms have been placed at the large overhead door openings to this building. Part of one of the berms has been removed on the west side of the building.

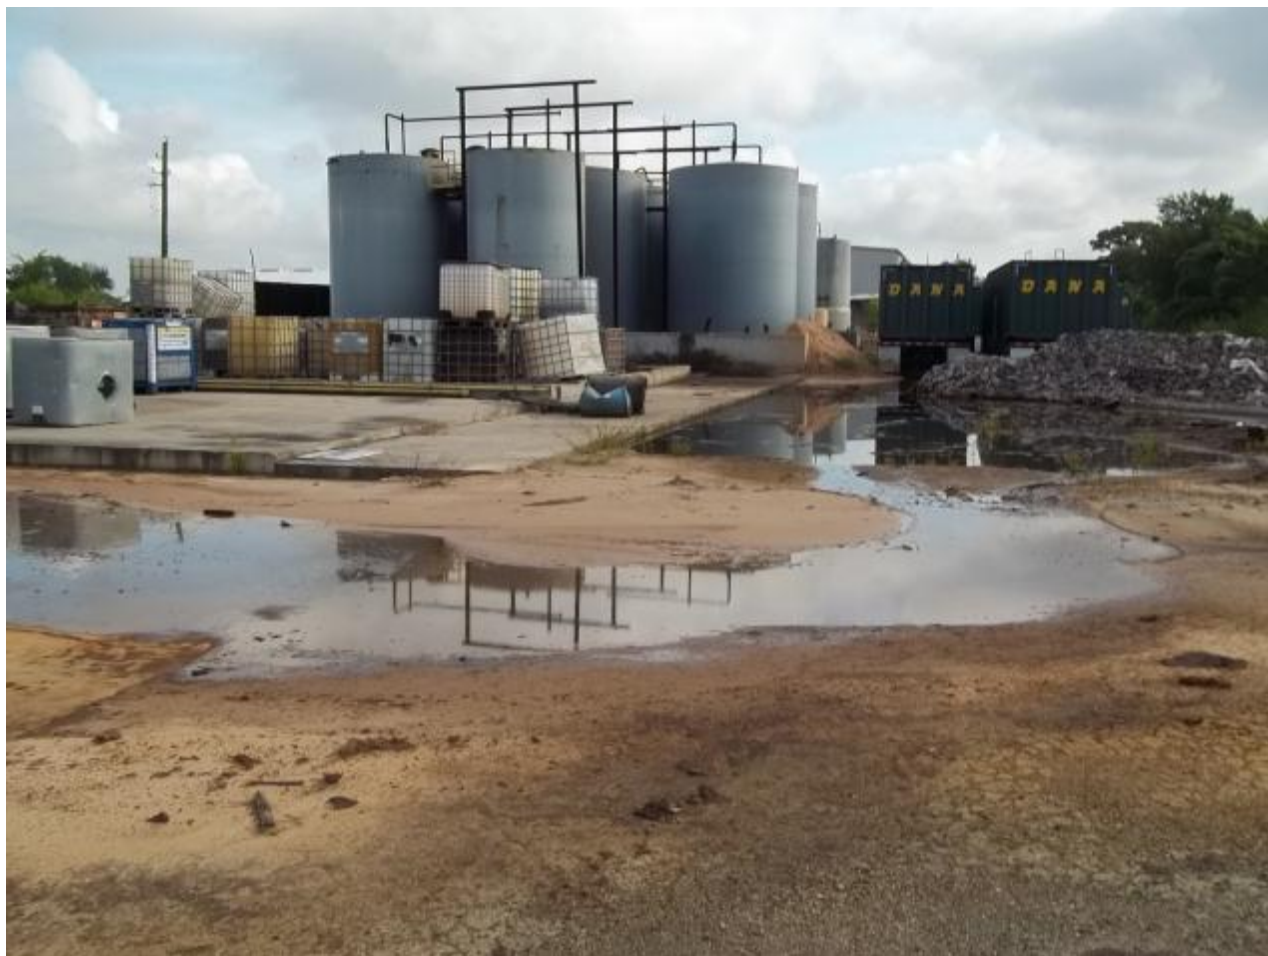
Photograph #8, August 2, 2014 – View looking north at the South Tank Farm area. Note the large frac tanks and a large pile of unknown material in front of the frac tanks. Also note the large aboveground storage tanks and totes in the South Tank Farm Area. The totes are reportedly empty but the aboveground storage tanks reportedly contain waste.

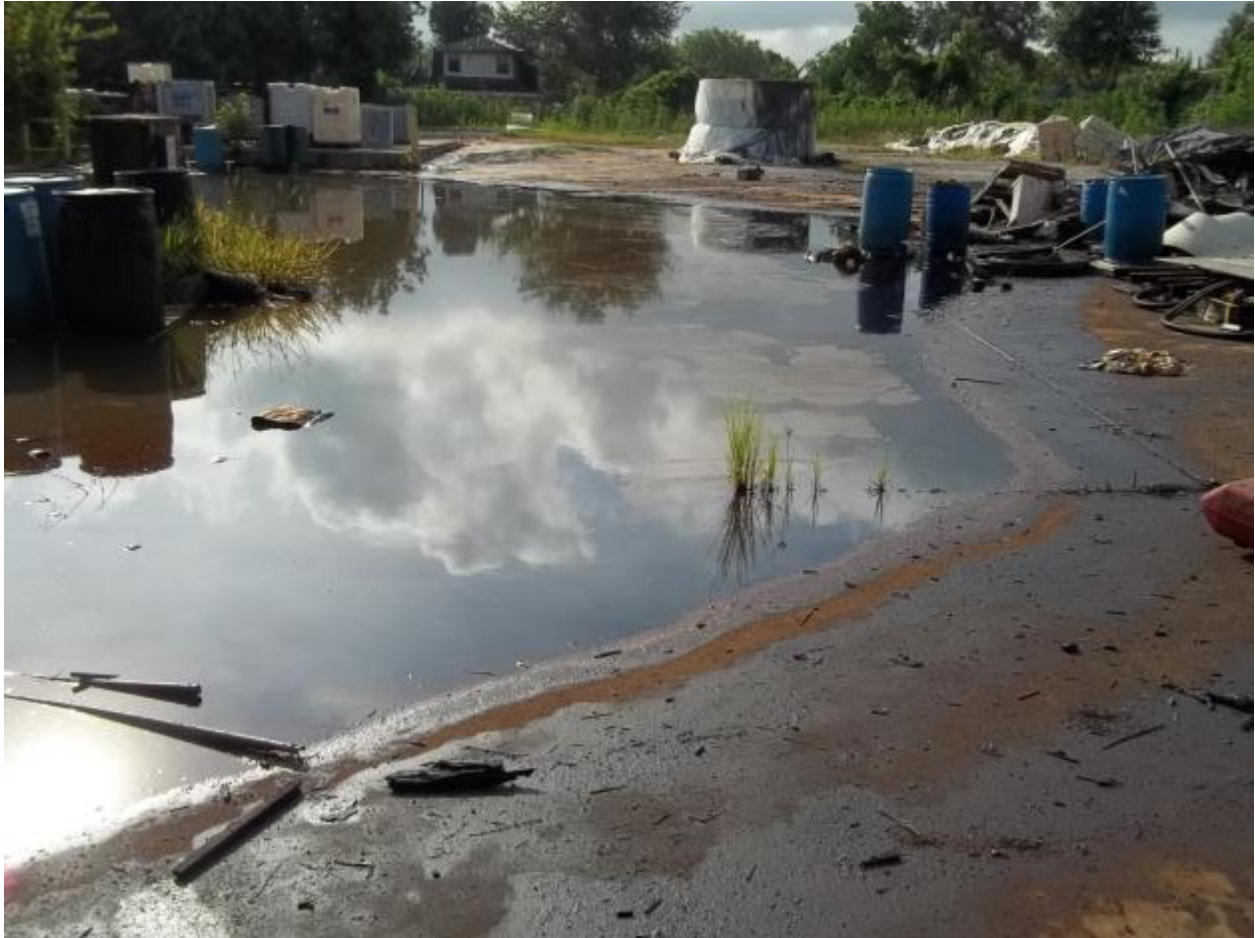
Photograph #9, August 2, 2014 - View looking east at the ponded stormwater, miscellaneous containers, and piles of debris located in the area south of the South Tank Farm. Note the residential properties in the background.

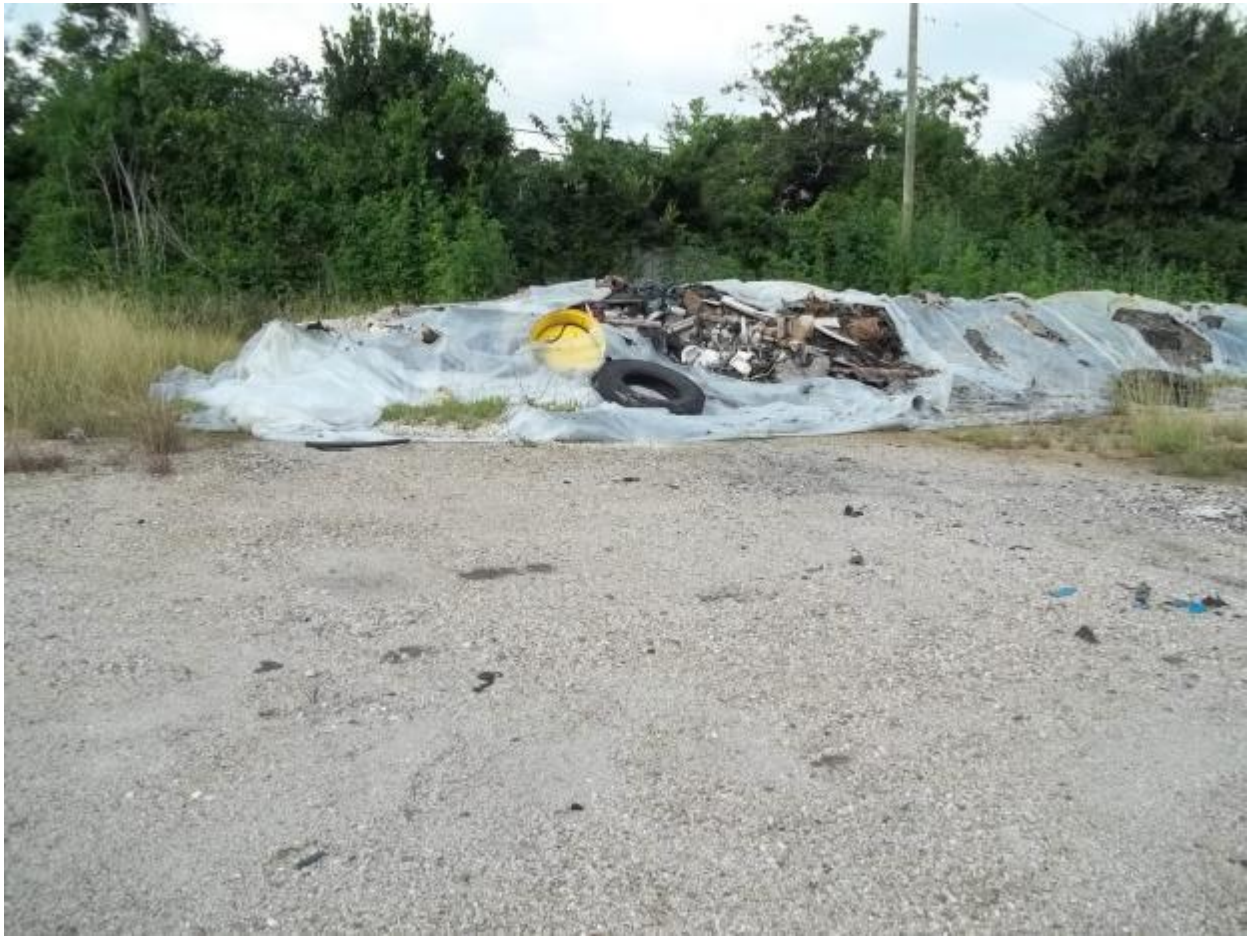
Photograph #10, August 2, 2014 - View looking south at a pile of debris located in the south part of the site. The debris was reportedly dumped out of the roll-off boxes during the theft of the roll-off boxes that reportedly occurred in March 2014. The plastic sheeting cover appeared to be in very bad shape.

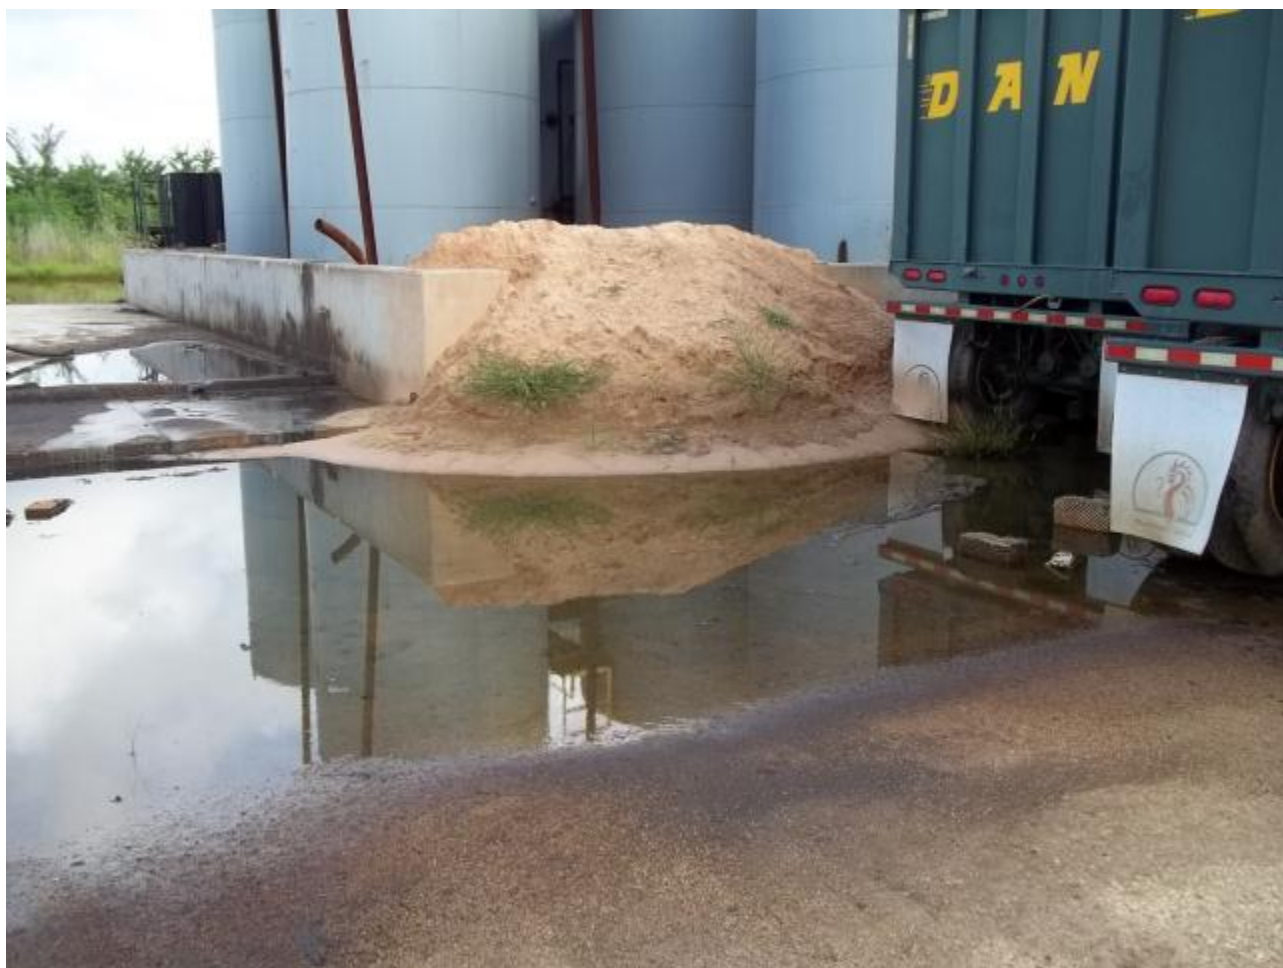
Photograph #11, August 2, 2014 - View of soil that has been placed in a large opening of the largest secondary containment area of the North Tank Farm Area.

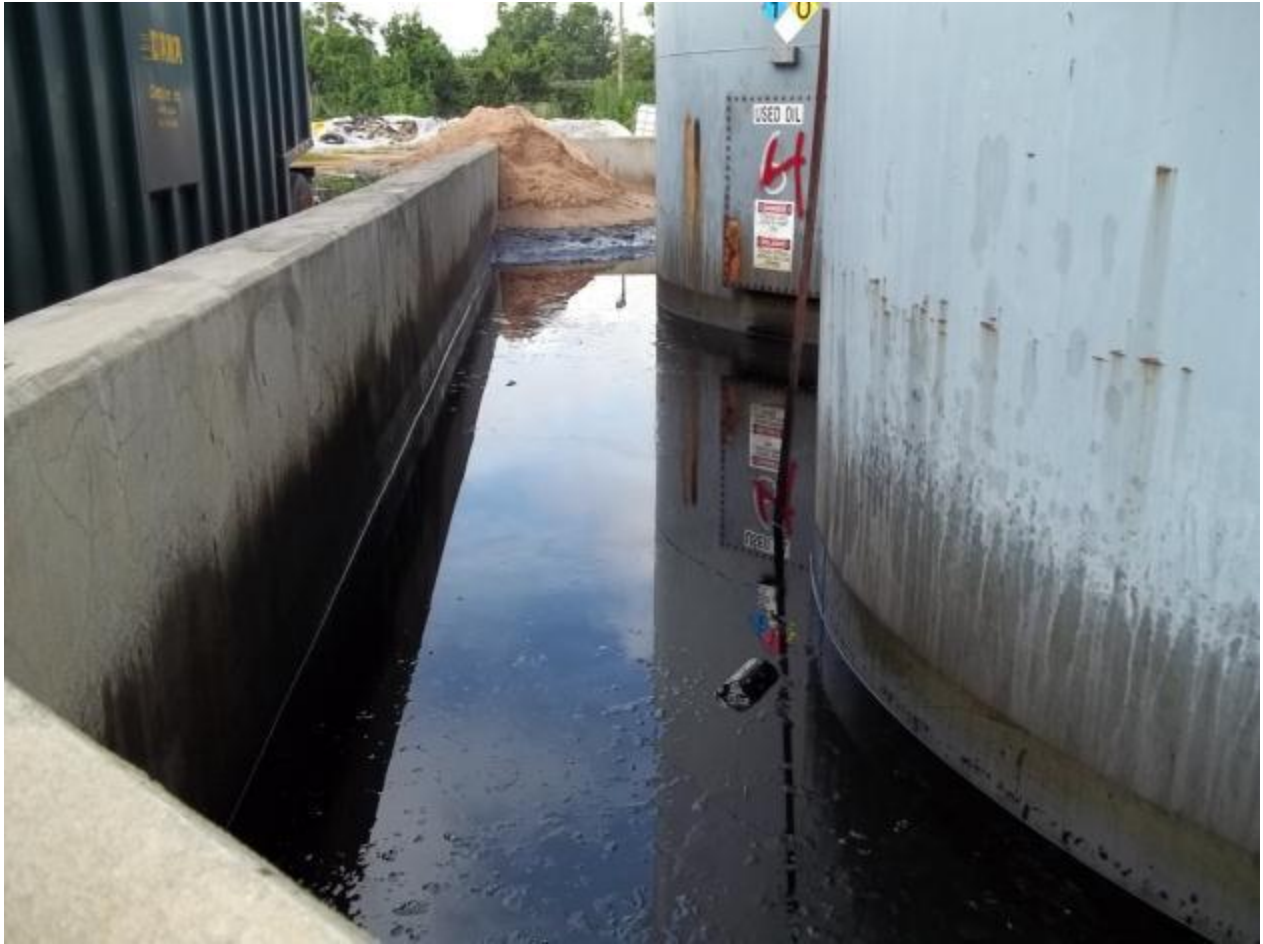
Photograph #12, August 2, 2014 - View looking south at the inside of the largest secondary containment area of the North Tank Farm. This area appears to contain a thick layer of oil. Note the soil pile that was placed at the secondary containment opening.

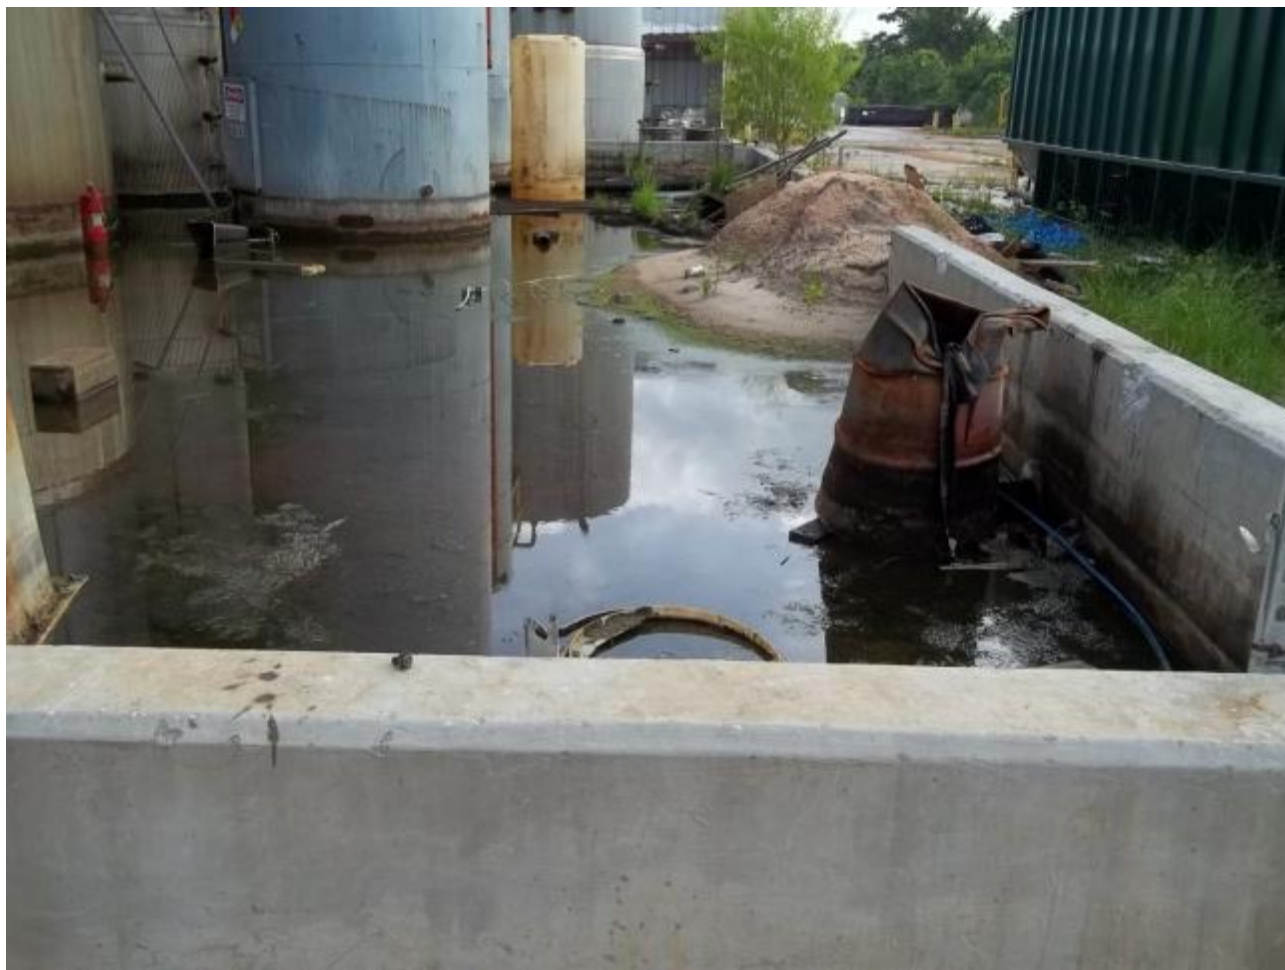
Photograph #13, August 2, 2014 - View looking north at another of the secondary containment areas within the North Tank Farm. Note the soil pile that was placed at the secondary containment opening.

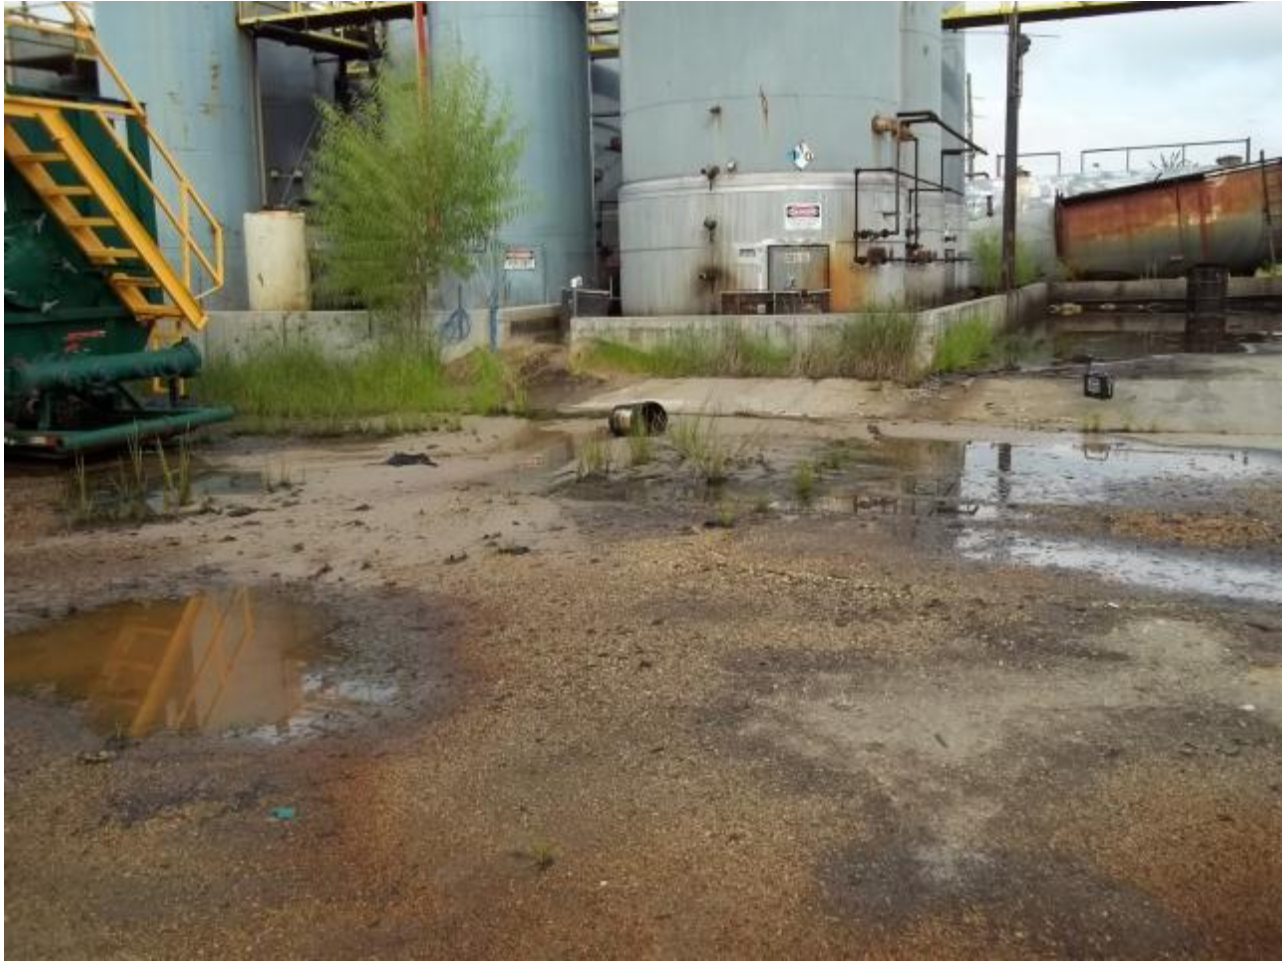
Photograph #14, August 2, 2014 - View looking west at the North Tank Farm. The soil that was placed at the opening of another of the secondary containment areas appears to be washed away.

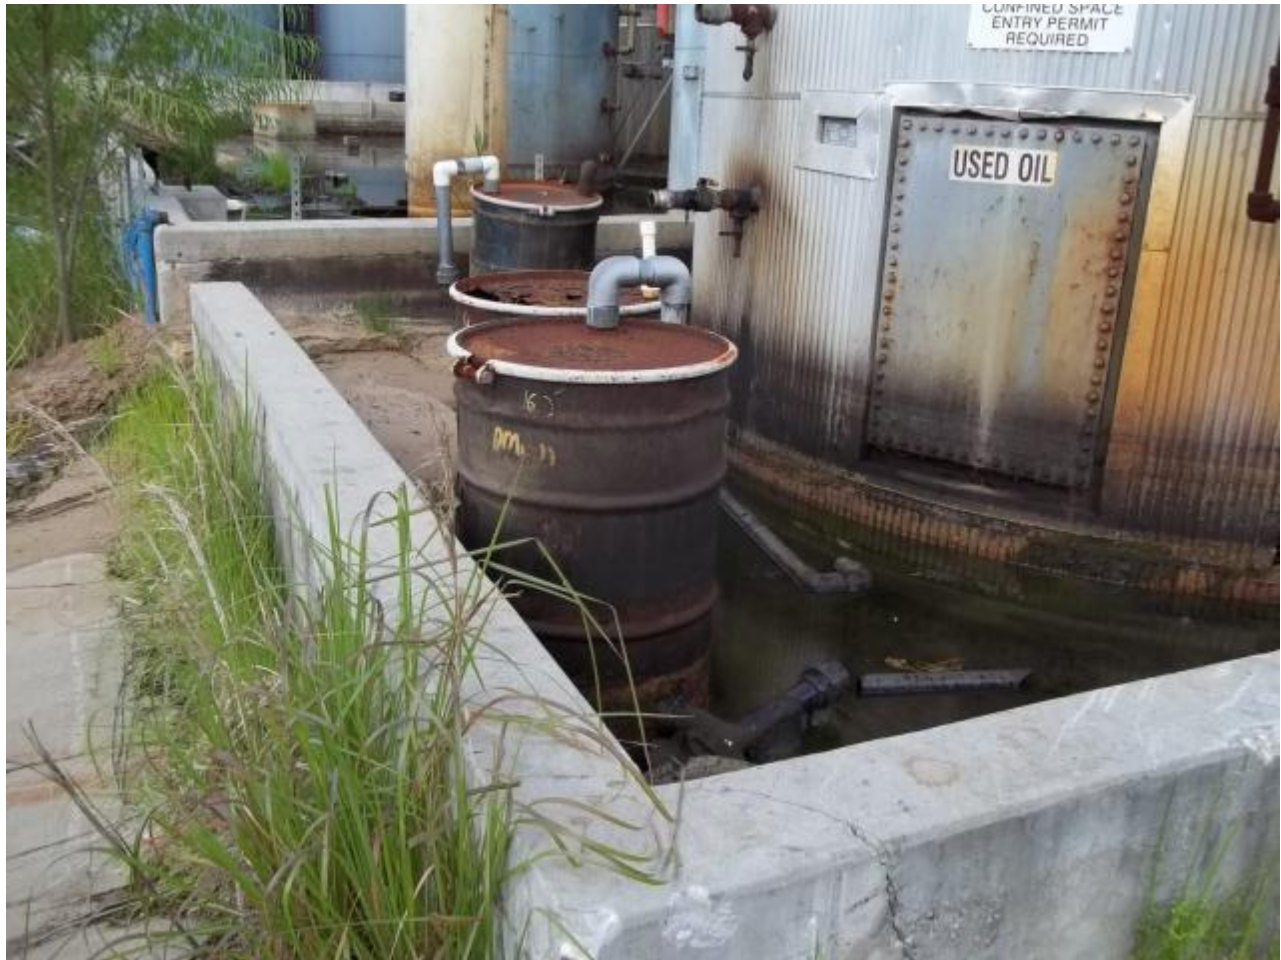
Photograph #15, August 2, 2014 - View looking southwest at the inside of a secondary containment area of the North Tank Farm. Note the soil pile that was placed at the secondary containment opening has been washed away.

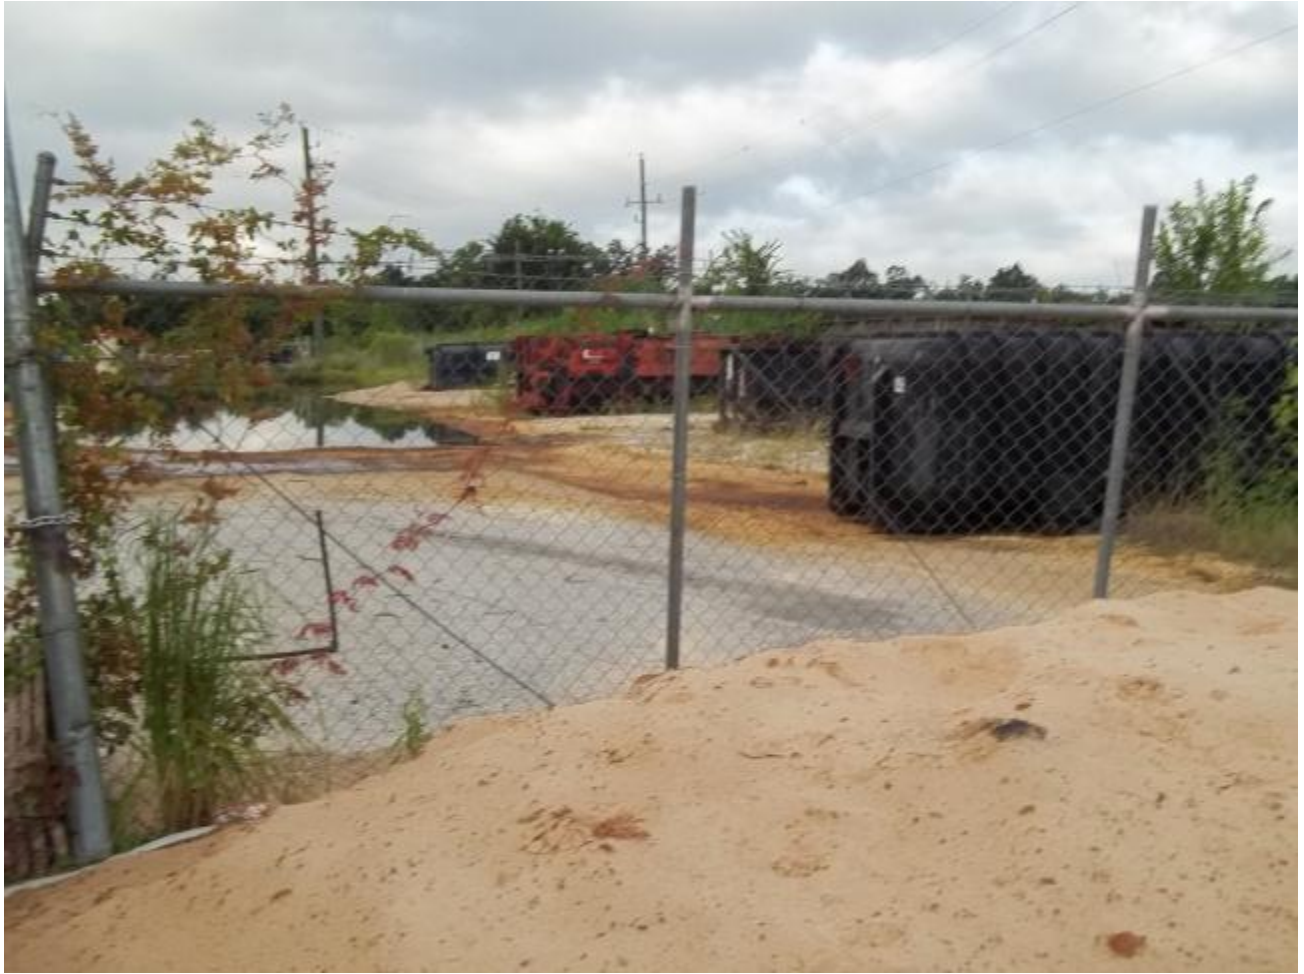
Photograph #16, August 12, 2014 - View looking south at the vacuum boxes and roll-offs staged along the western fence of the main facility. The gate in the foreground (with soil berm) is located at the end of Wayland Street.

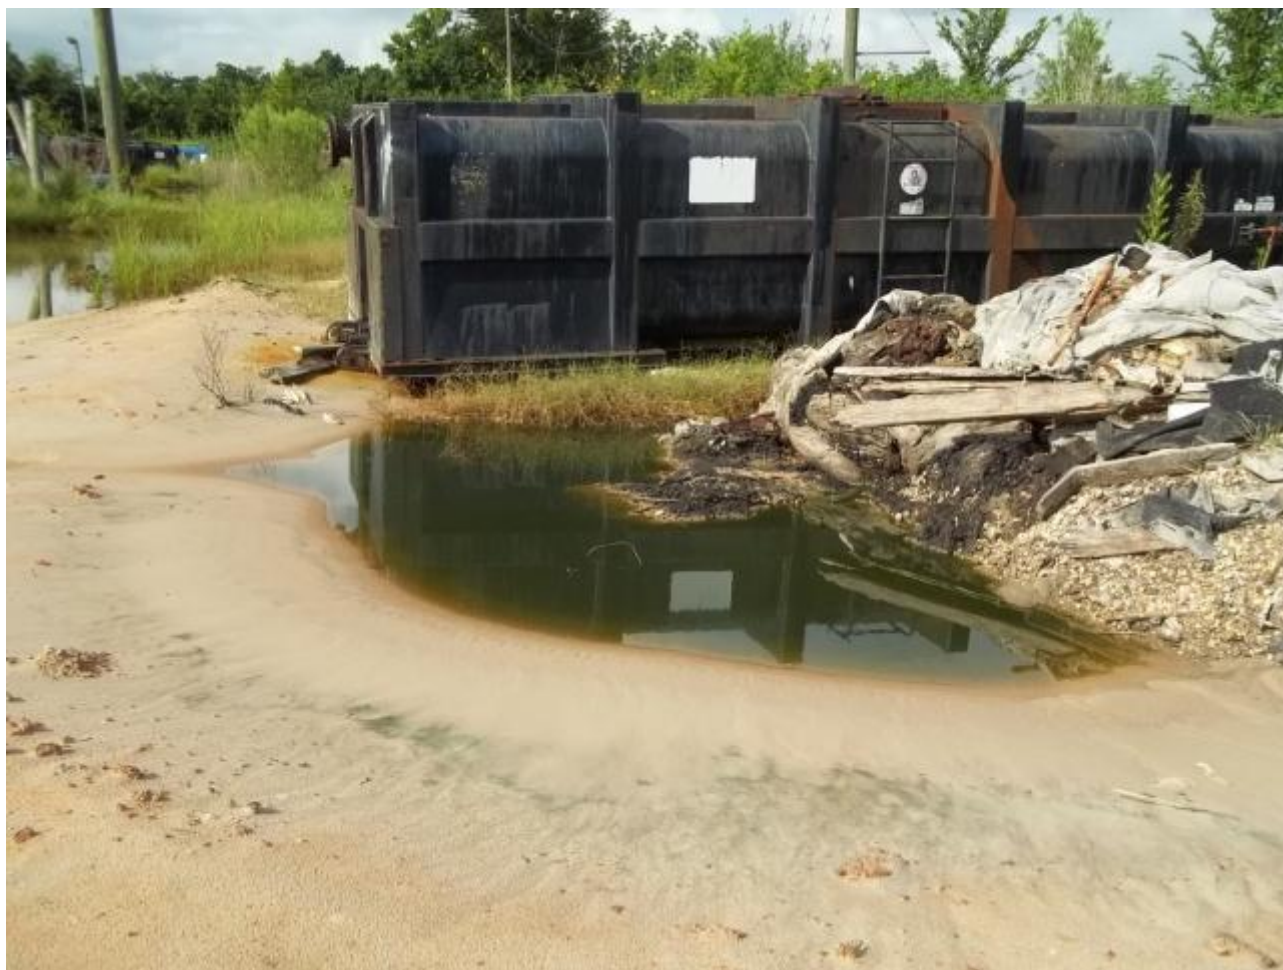
Photograph #17, August 2, 2014 - View looking south at vacuum box 617 that is staged near the perimeter fence (west of the North Tank Farm). This box had been leaking from the bottom of the container. A soil berm has been placed around the vacuum box.
